**DEPARTMENT OF TRANSPORTATION**

Contract #: 04-0120F4Cty: SF/ALA Rte: 80 PM: 13.2/13.9File #: 69.28**WELDING INSPECTION REPORT****Resident Engineer:** Pursell, Gary**Address:** 333 Burma Road**City:** Oakland, CA 94607**Report No:** WIR-001740**Date Inspected:** 16-Mar-2008**Project Name:** SAS Superstructure**OSM Arrival Time:** 1830**Prime Contractor:** American Bridge/Fluor Enterprises, a JV**OSM Departure Time:** 730**Contractor:** Zhenhua Port Machinery Company, Ltd (ZPMC), Changxing Island **Location:** Shanghai, China

**Bridge No:** 34-0006**Component:** u-rib deck panel**Summary of Items Observed:**

Caltrans Quality Assurance (QA) Inspector, Mike Hasler was present to observe the fitup, welding and related activities associated with the fabricating of Caltrans Mock-up, 77M, 89M, 114M and orthotropic box girders (OBG), for the San Francisco Oakland Bay Self Anchored Suspension Bridge, at Zhenhua Port Machinery Company (ZPMC) facility on Changxing Island.

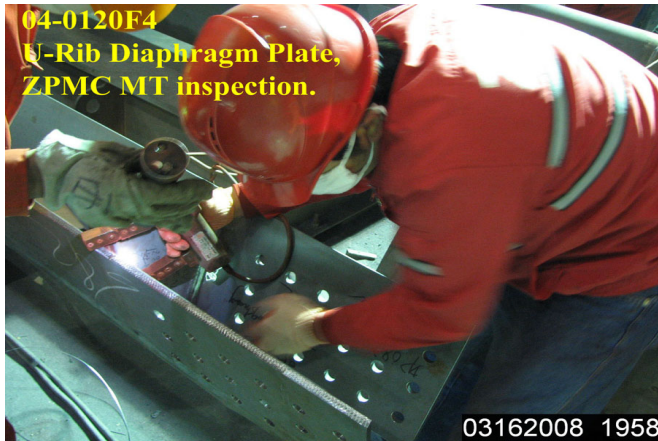
OBG Bay 1: ZPMC presented ZPMC Notification of witness inspection for magnetic particle testing of final weld DP083-001-012 at 1920 hours. Caltrans QA witnessed ZPMC QC perform magnetic particle (MT) on fillet weld, diaphragm plate joining u-rib, weld identified as 012. The ZPMC QC inspector is identified as Mr. Zhou Dongyan. Caltrans observed that the QC MT coverage was 100% and performed in conformance with the contract specifications. The following digital picture illustrates ZPMC MT inspection in progress.

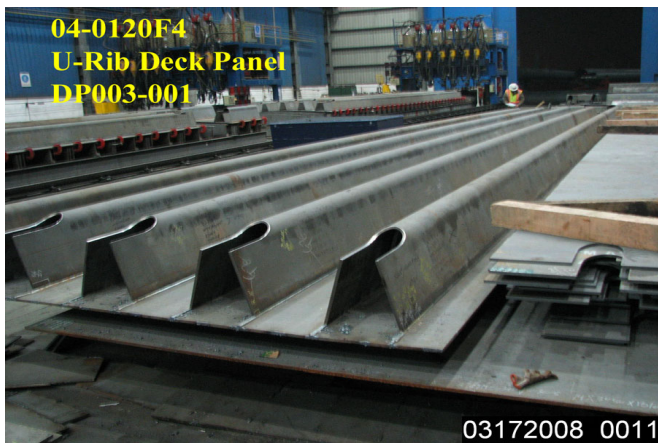
- OBG Bay 1: Caltrans QA Inspector performed visual inspection of the completed submerged arc welding (SAW) cover pass welds; partial joint penetration (PJP) welds joining the closed ribs to deck plate panel DP042-001, u-rib U150, welds 1 & 2; u-rib U138, weld 3 and DP003-001, u-rib U122, welds 9 & 10 and u-rib U145 weld 8. Caltrans QA observed welding overlap, over size welds, underfill and incomplete fusion. These indications observed at the weld were marked in yellow paint stick along the distance from the "Y" axis, starting at the weld start too weld completion end. The weld indications observed were recorded on Caltrans spreadsheet for future reference. The following digital pictures illustrate u-rib deck plate panel DP003-001.
